Report 22-07.a

AliClad horizontal and vertical aluminium weatherboard cladding system in accordance with AS/NZS 4284:2008 'Testing of Building Facades'

Project:	AliClad weathertightness
Client:	The Building Agency 14A Link Drive Wairau Valley Auckland, 0627
Specifier:	The Building Agency
Sample designer:	The Building Agency
Installer:	The Building Agency
Test dates:	2 - 3 June 2022
Test Schedule:	The test order specified in AS/NZS 4284:2008 was followed, with sections a, b, c, d, e, g, and h requested.
Persons present:	Richard Gibbs (Facadelab manager), and for parts of the testing: Emmett King, Mark Cinco, Lawrence Alcazar, Ranesh Prasad, Andre Van Der Walt.
Test facility:	Facadelab Ltd, 320 Rosedale Rd, Albany, Auckland.

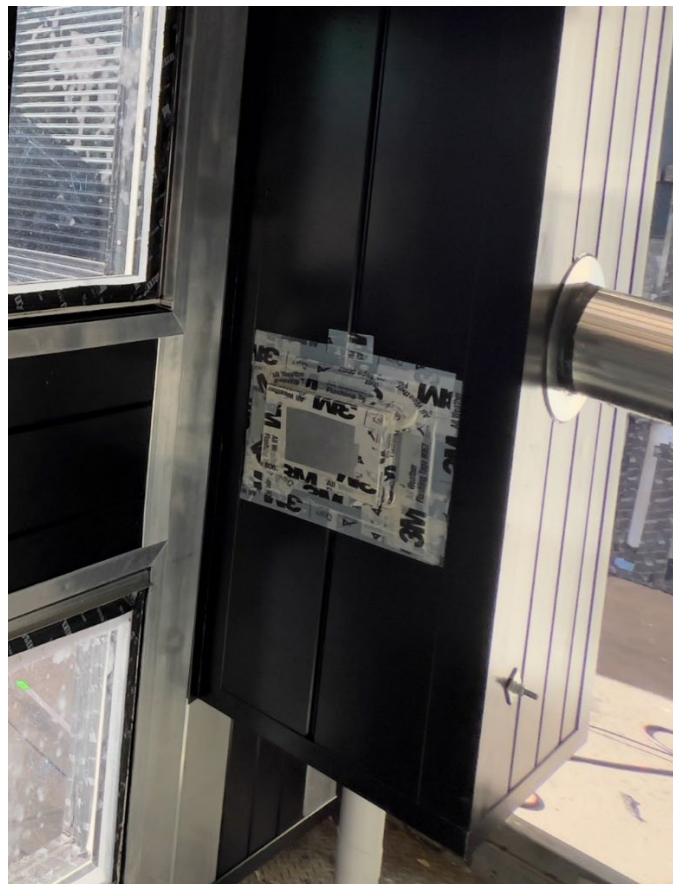
Figure 3: Letter box- sealed to remove from the test

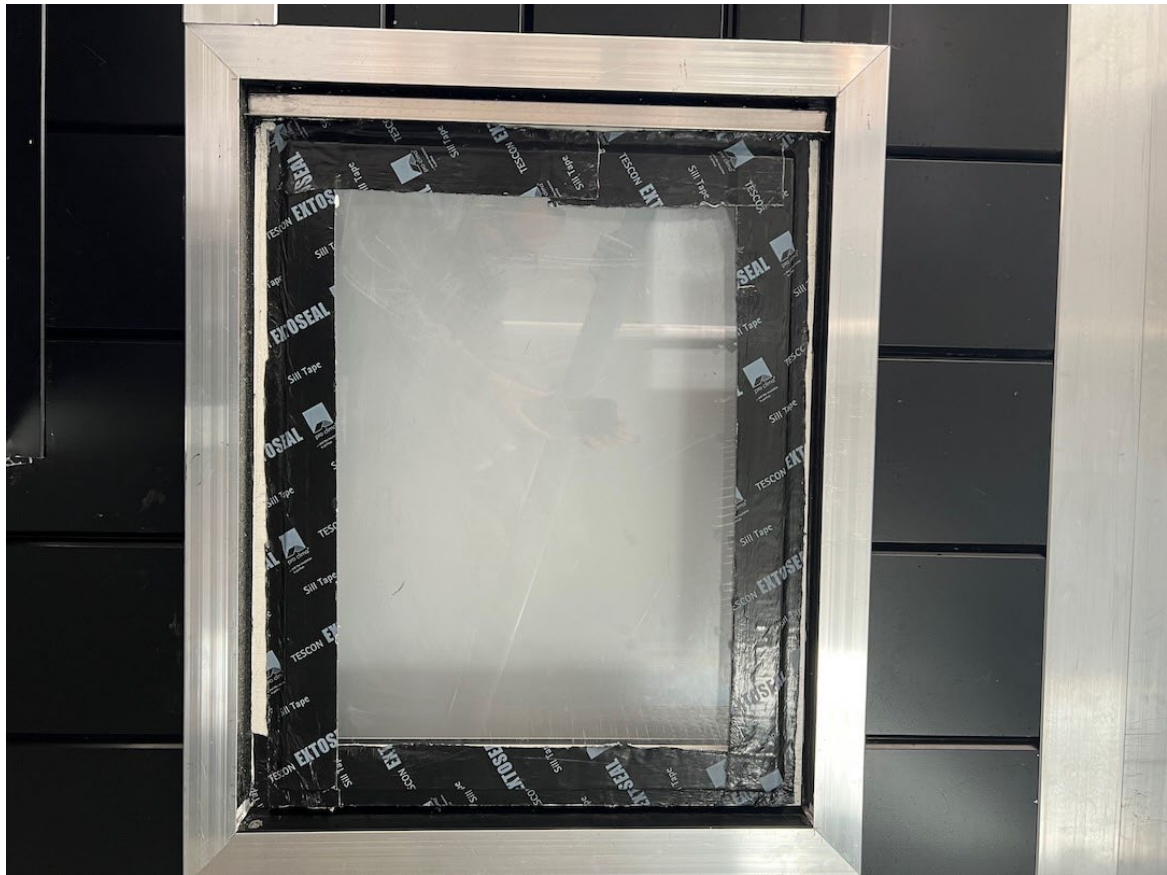
Figure 4: Window taped up to remove the glazing-to-frame joint from the testing

Water was noted on the backs of boards in some locations below complex joints, which remained controlled within the cavity, although some water was able to contact the inside of the polycarbonate which was taking the place of a rigid air barrier. (These issues were addressed in the later testing by removing the windows from the test).

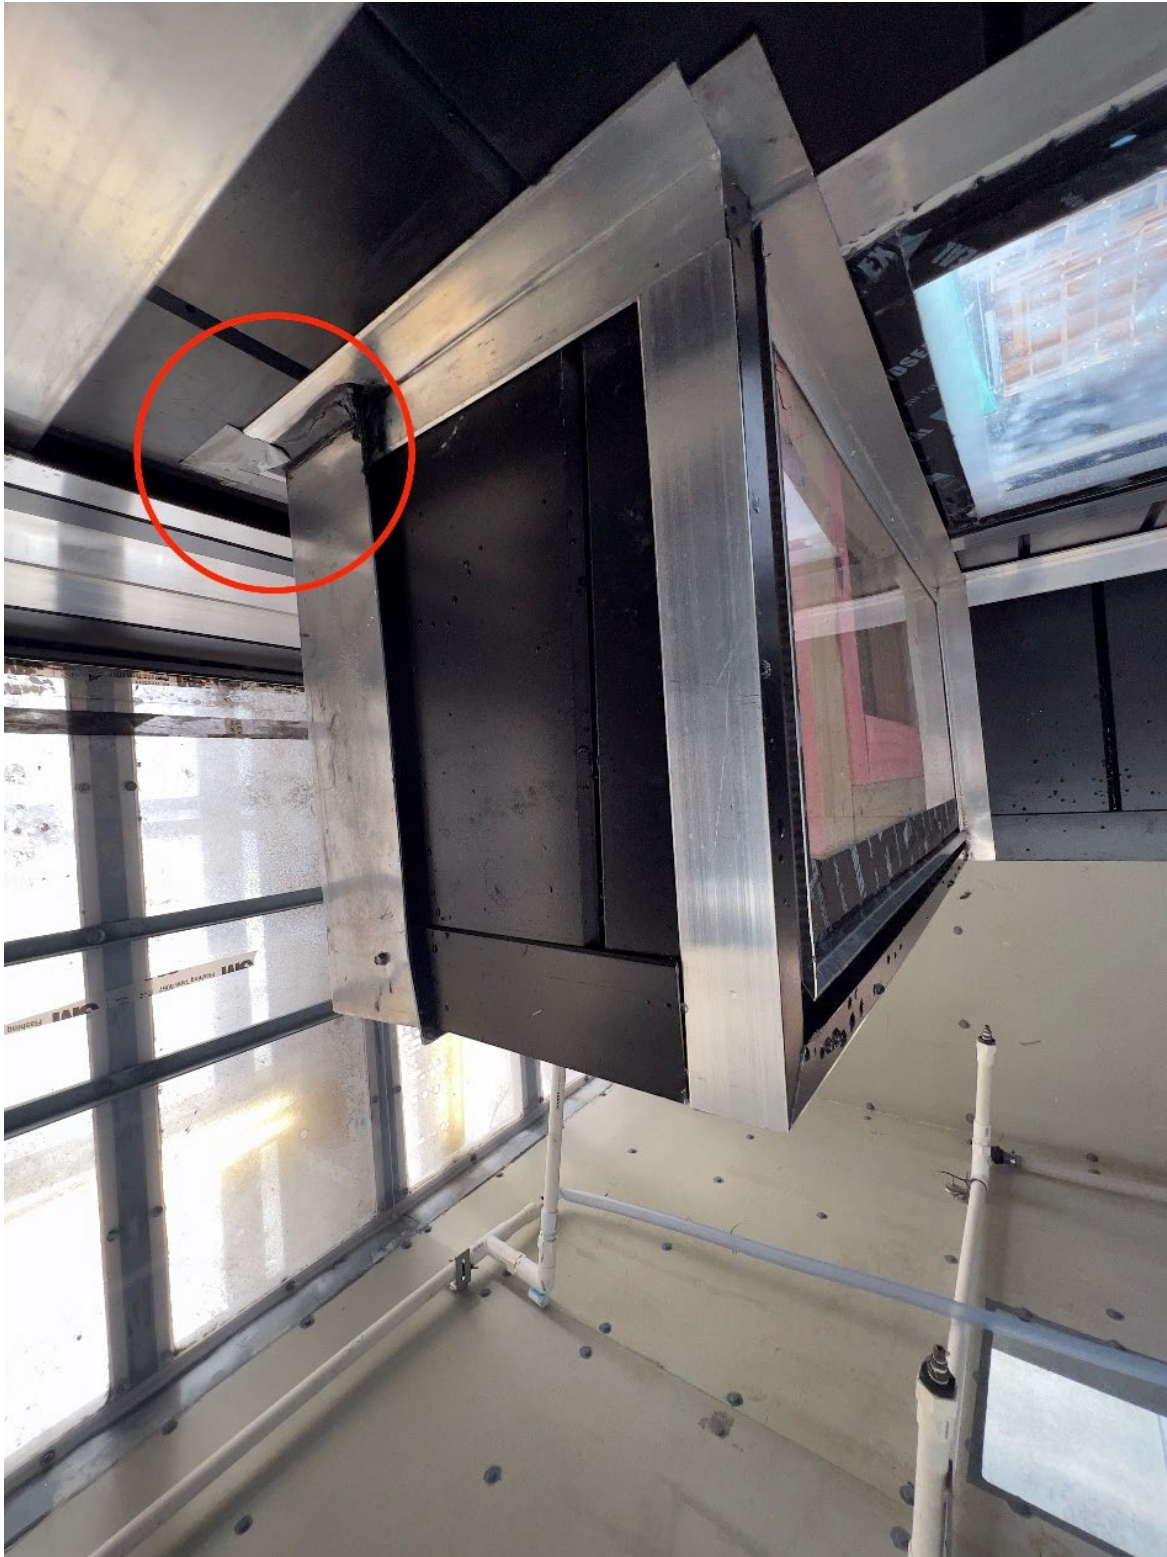
Figure 5: Parapet- sealed to remove from the test

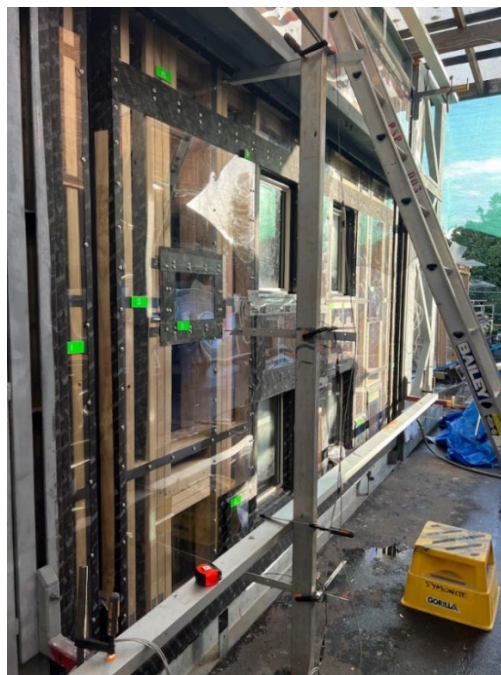
The displacement transducers were located as close as possible to the end of the timber stud. The photo shows the actual locations as tested which was within 5 mm of the end of the stud.

Figure 6: SLS displacement transducers on stud

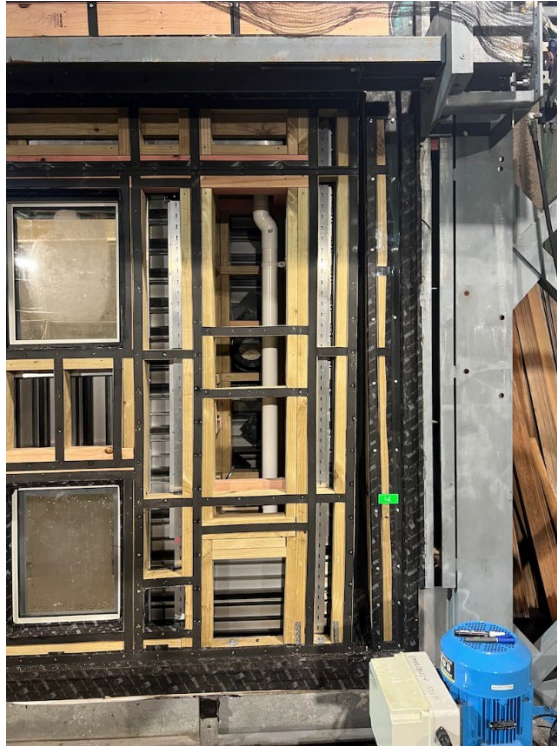
Figure 8: Photo of specimen racking at maximum extent, showing gap at bottom of jamb stud.
