THE BUILDING AGENCY LIMITED – AS/NZS 4284

Shelby Wright Test Report

SWTL Reference:
J-24008

Testing of The Building Agency Limited's Aliclad V085 & S085 vertical weatherboard cladding system was carried out at Shelby Wright Test Labs (SWTL) Avondale laboratory. The sample was prepared by the client and installed in the test booth by the client in August 2024.

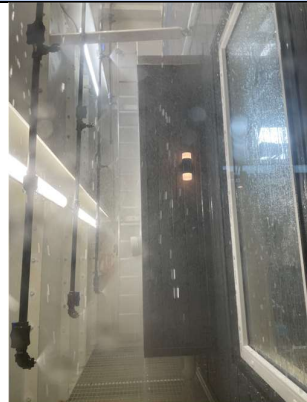
Obs. No:	Test	Observation	Photo
1	Water testing – All	No leaking or water penetration evident.

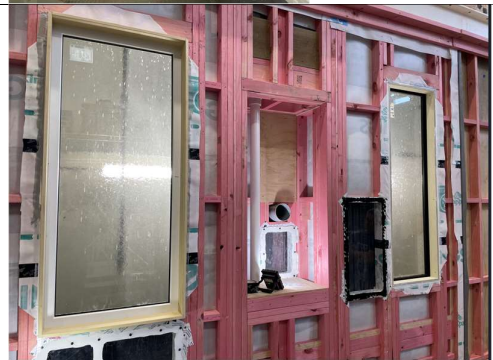
2	Water testing – All	No leaking or water penetration evident.

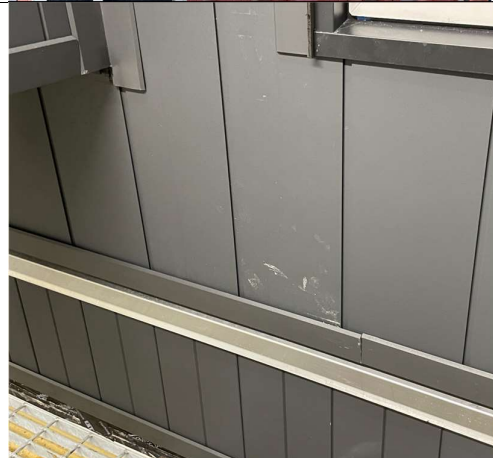
3	Post Structural ULS Negative Pressure	Partial dislodgement of the horizontal inter-storey flashing.

Comments	The horizontal inter-storey joint snap-fit cover strip flashing was partially dislodged due to movement of the cladding boards underneath the right hand side window as viewed from inside the test booth after negative ULS pressure application.

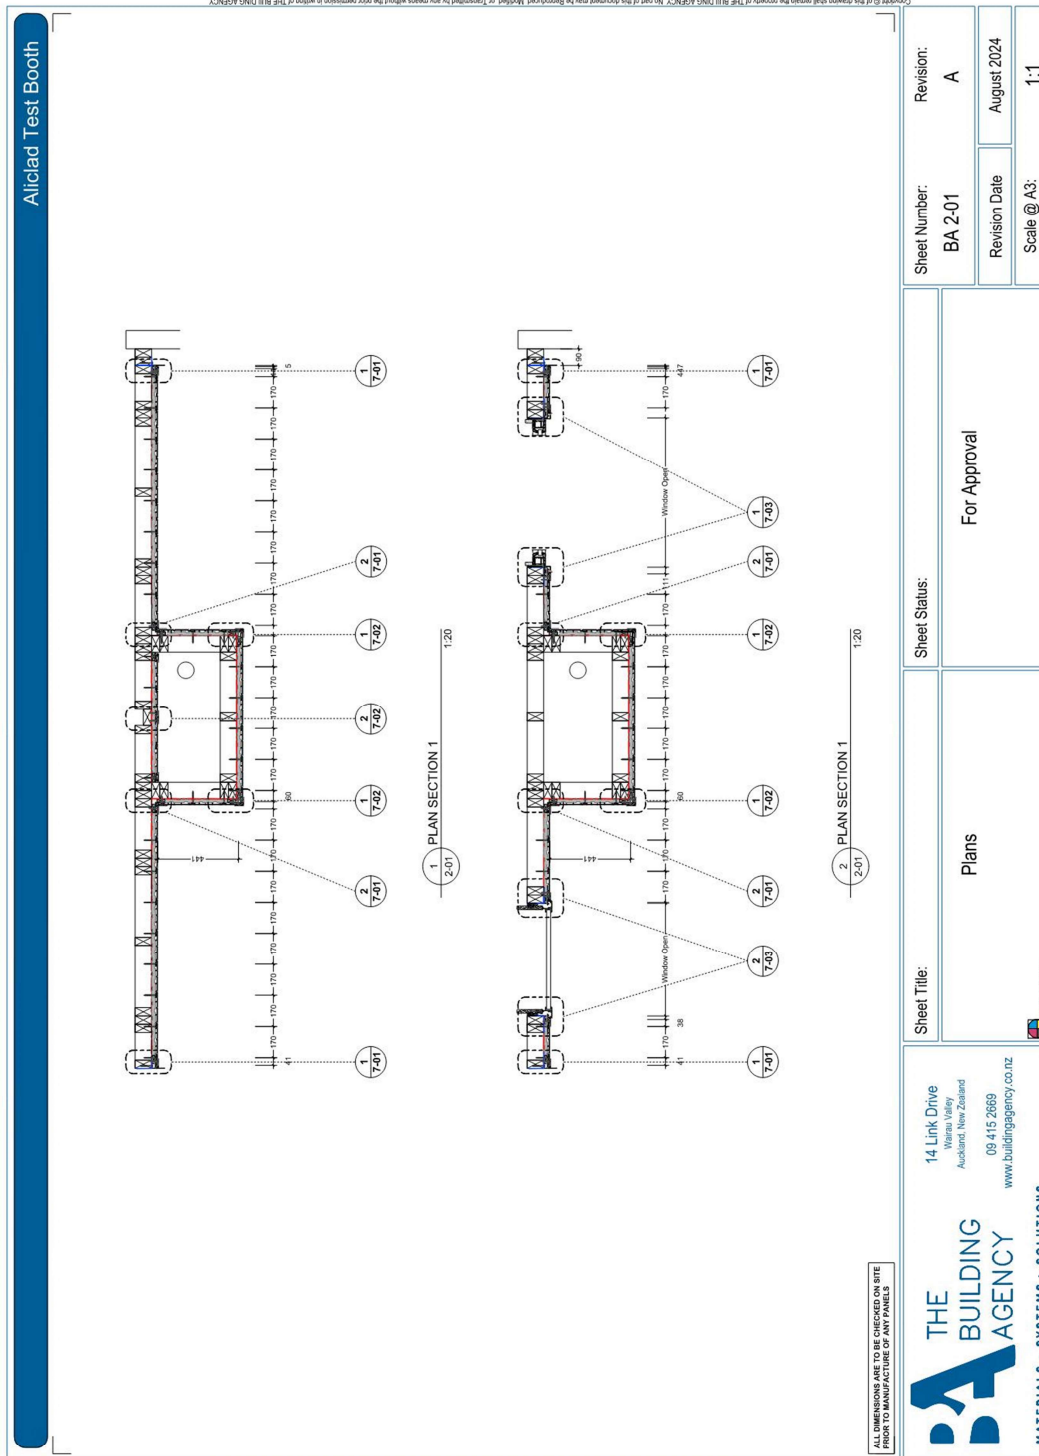
Sheet Number:	BA 2-01	Revision:	A
Revision Date	August 2024	Scale @ A3:	1:1

Plans
